ACKENHEIL AND ASSOCIATES INC PITTSBURGH PA
NATIONAL DAM INSPECTION PROGRAM. BRESKIN DAM NUMBER 2 (NDI NUMB--ETC(U)
JUL 80 J P HANNAN, J E BARRICK

PHASE I INSPECTION REPORT
NATIONAL DAM INSPECTION PROGRAM

BRESKIN DAM No.2

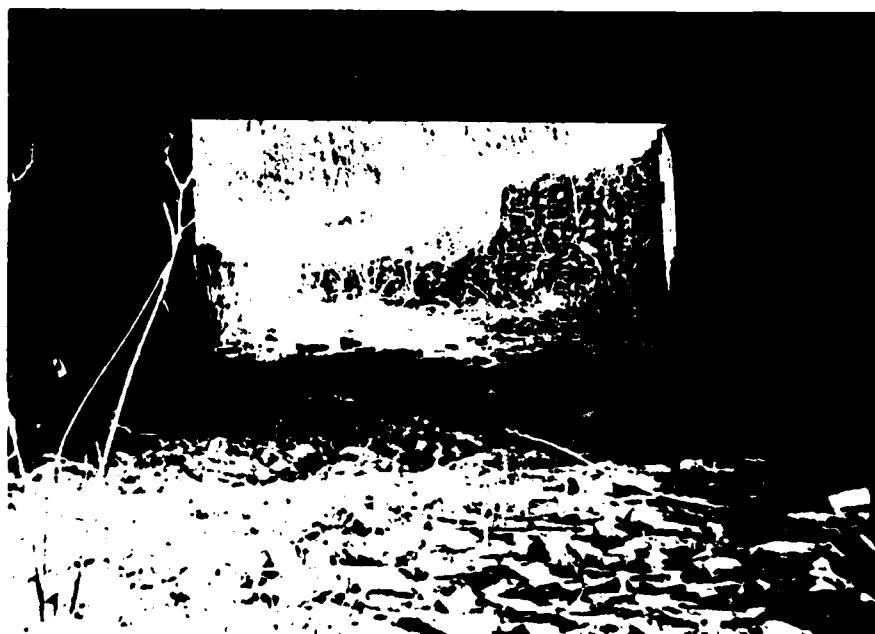
PHOTO 10. PRINCIPAL SPILLWAY CHANNEL

c. Principal Spillway: The principal spillway was observed to be in good condition. There were no flow obstructions that would compromise spillway performance during flood flows.

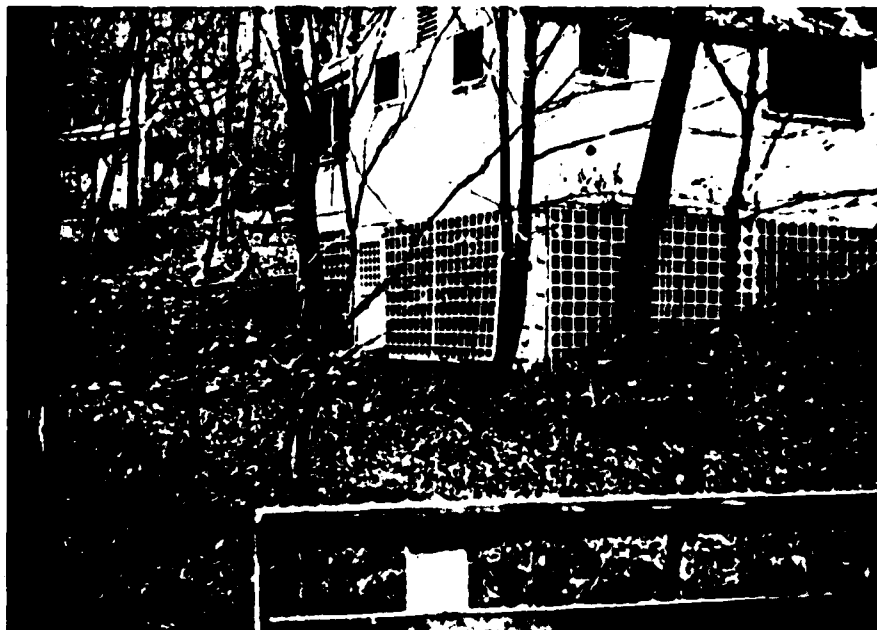
PHOTO 13. DOWNSTREAM HAZARD

(5) Downstream Conditions: The unnamed tributary to Fourmile Run, passes through a relatively steep sided, narrow valley, below the dam. Approximately 3,000 feet below the dam the stream enters Fourmile Run. Fourmile Run flows into Loyalhanna Creek west of Latrobe. There are approximately five inhabited dwellings in the floodplain within the first 3,000 feet below the dam.

d. Hazard Classification: Breskin Dam No. 2 is classified as a "high" hazard dam. In the event of a dam failure, at least five inhabited dwellings within the first one half mile downstream would be subjected to substantial damage and loss of life could occur.
